# Progress Update: Assessing Aquatic Connectivity in the Black River Watershed

**Rebeckah Hollowell**  
*Environmental Scientist*  
Moffatt & Nichol

February 24, 2020

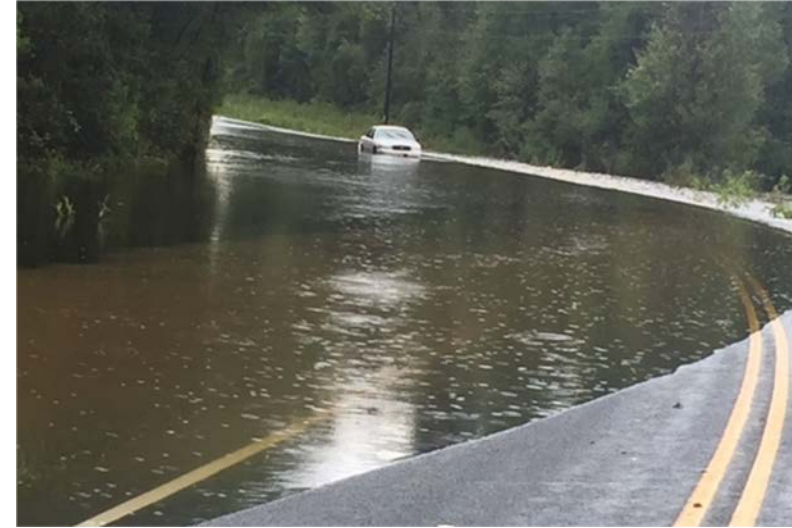
**Hurricane Florence flooding on a road in Bladen County**

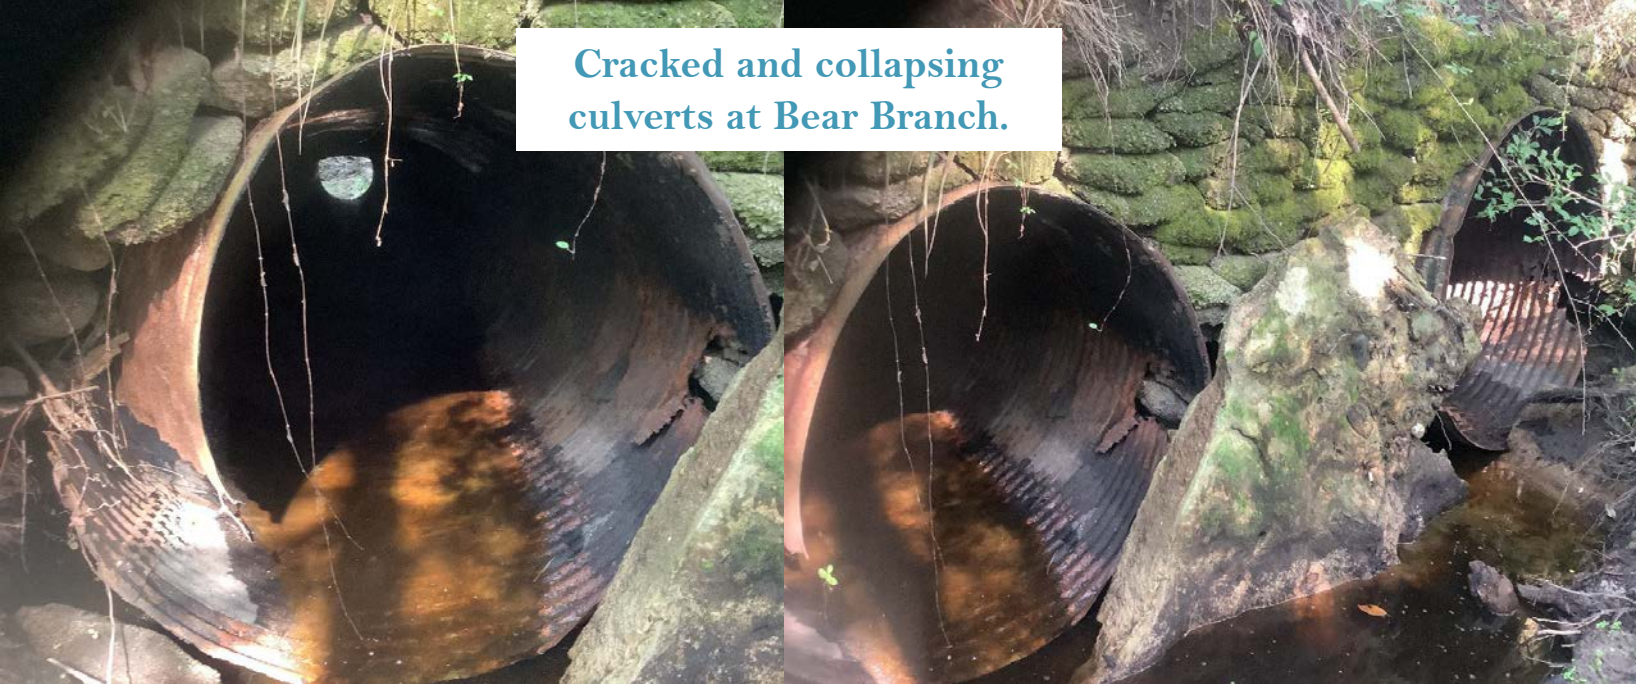
**Cracked and collapsing  
culverts at Bear Branch.**

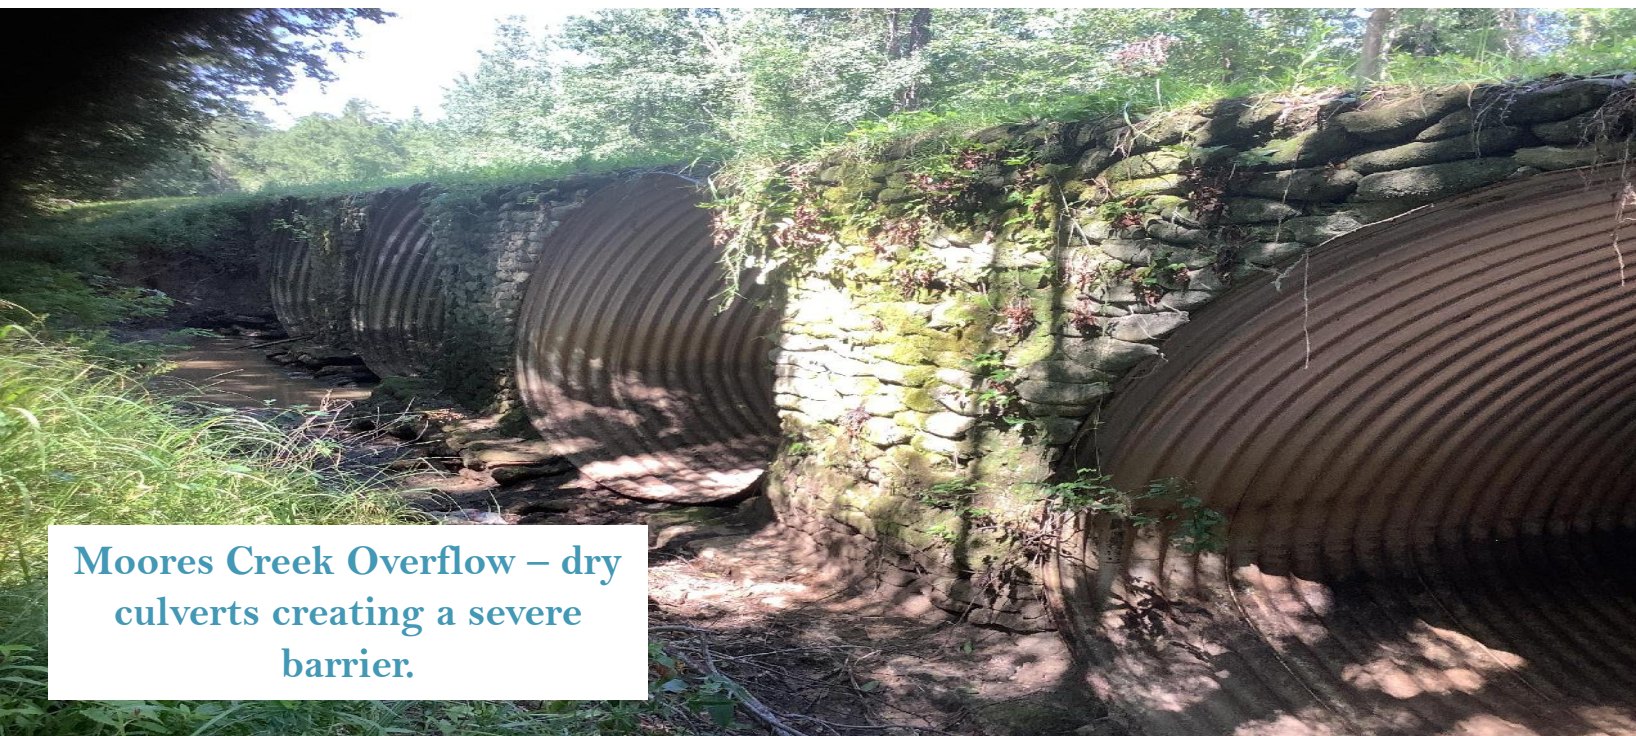
**Moore's Creek Overflow – dry  
culverts creating a severe  
barrier.**

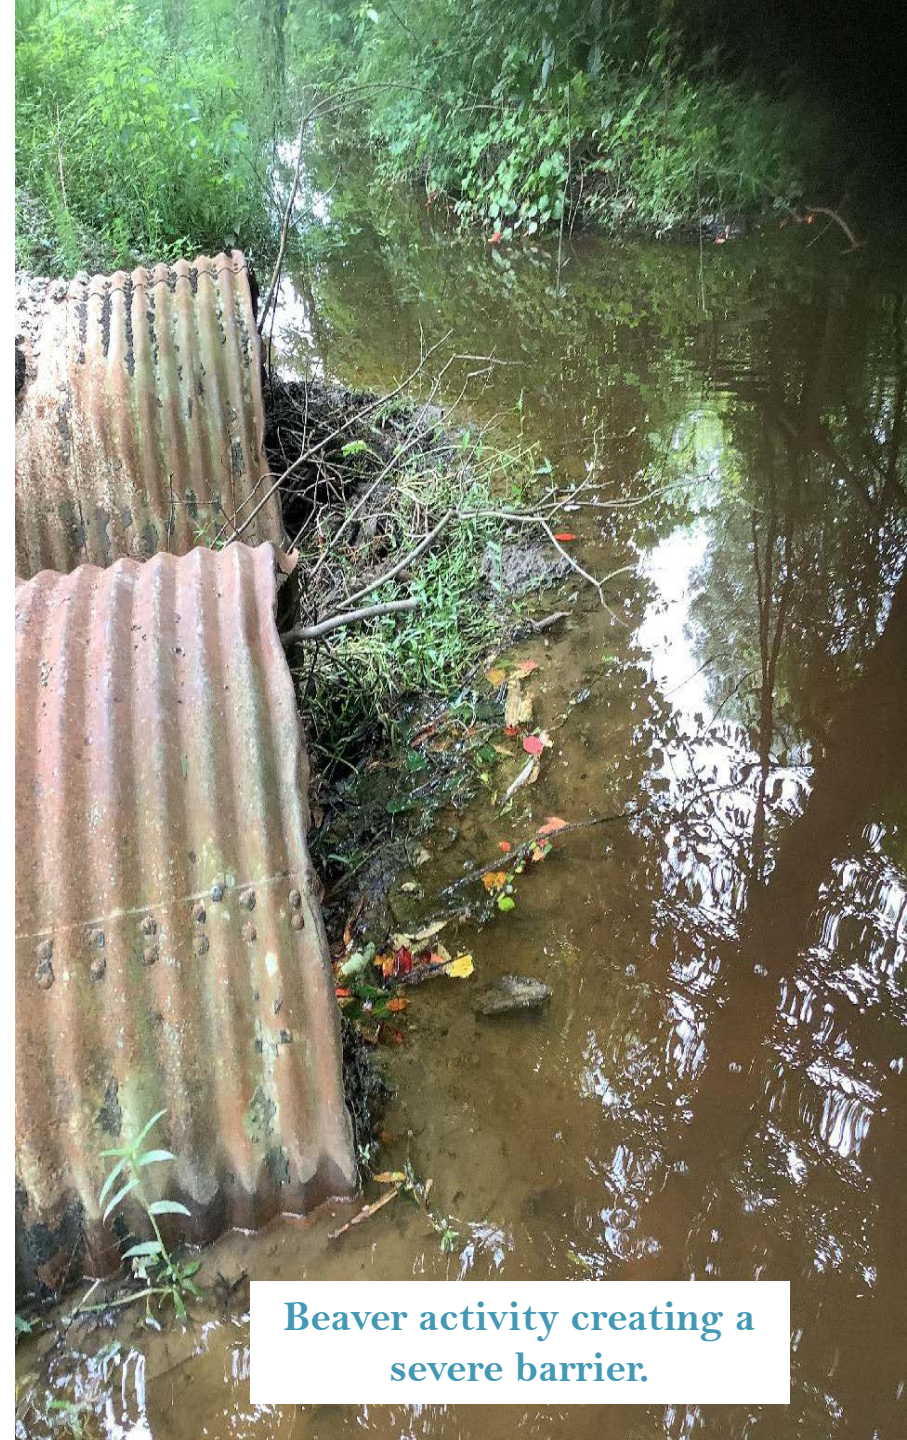
**Beaver activity creating a  
severe barrier.**
