In-Depth Hydrologic Assessment Cape Fear Survey Area

A detailed assessment of hydrologic barriers in the Hood Creek watershed of the Cape Fear River Basin was completed. This effort included field surveys and data collection according to the tidal barrier assessment method, and a desktop analysis of drainage density and capacity. The results have been combined to develop a prioritized summary of recommended retrofit actions in the watershed.

11.15.2022

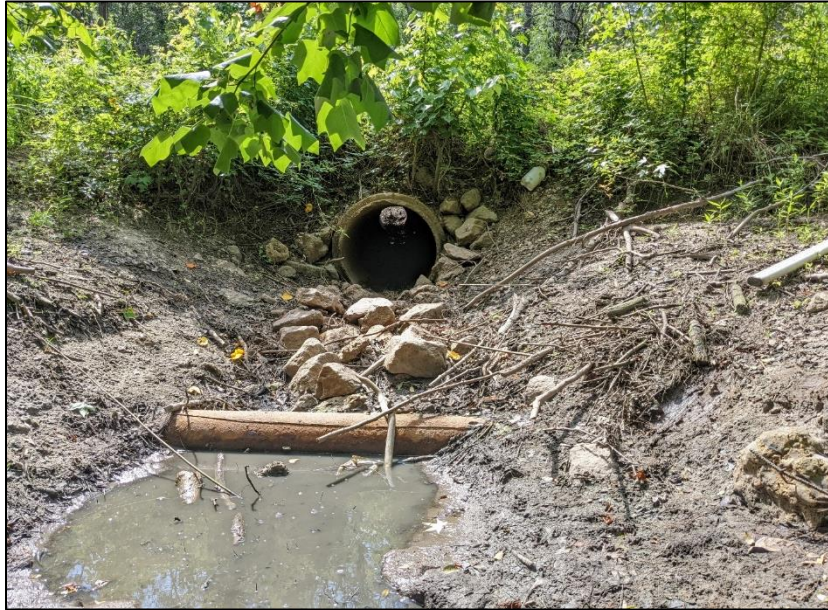
CPF133 is a single 30" RCP in an intermittent or ephemeral channel. Though the channel was dry while the survey occurred, the outlet pool still retained water. Many small fish were observed in the pool, which seemed likely to dry up in a few days. The outlet pipe was slightly perched, and a utility pipe ran perpendicular to the stream channel directly downstream of the pipe. This crossing is the most downstream of a group of three culverts, with CPF354 and CPF356, located within a ½ mile of each other. Though the utility pipe presents a challenge, the downstream channel could be regraded and pipe buried to allow passage upstream.

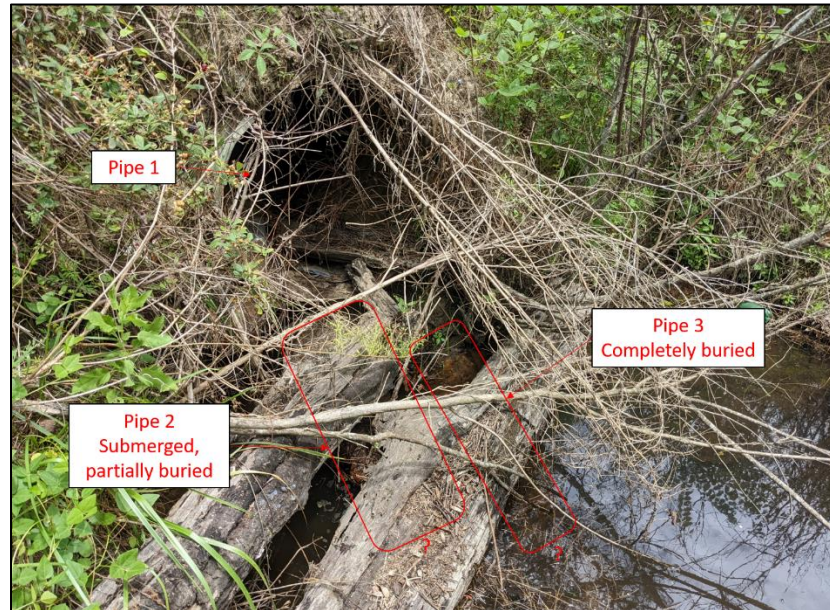
CPF138 is a group of three culverts in poor shape. One CMP was perched significantly above the water both upstream and downstream, and appeared to rarely receive flow. Two further pipes were submerged below the water and debris, and the inlet openings were buried in the stream bed. Slight flow was observed downstream, suggesting that some water is passing through the buried pipes. However, it seems unlikely that fish passage is possible except in high flow events. The road above these culverts is not paved, however it appears to be the only point of access to several houses beyond the culvert crossing. If access issues can be resolved, these culverts could be replaced with a larger culvert or small bridge to improve passage.

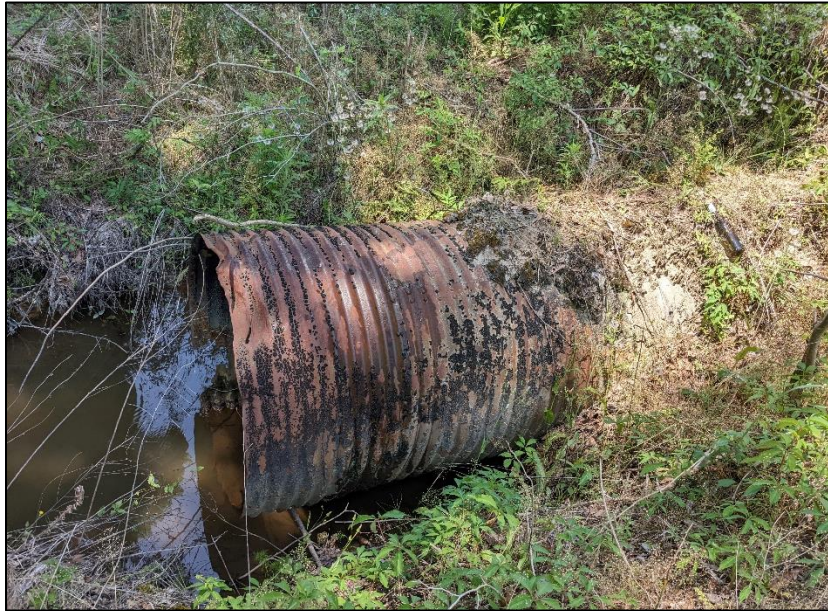
CPF248 is a single CMP in failing condition. The culvert is rusted through in several areas and erosion above the pipe is approaching the road. This erosion should be repaired to preserve the integrity of the road. Removal and replacement of the current culvert with a larger barrel size could help to prevent further erosion in the future.

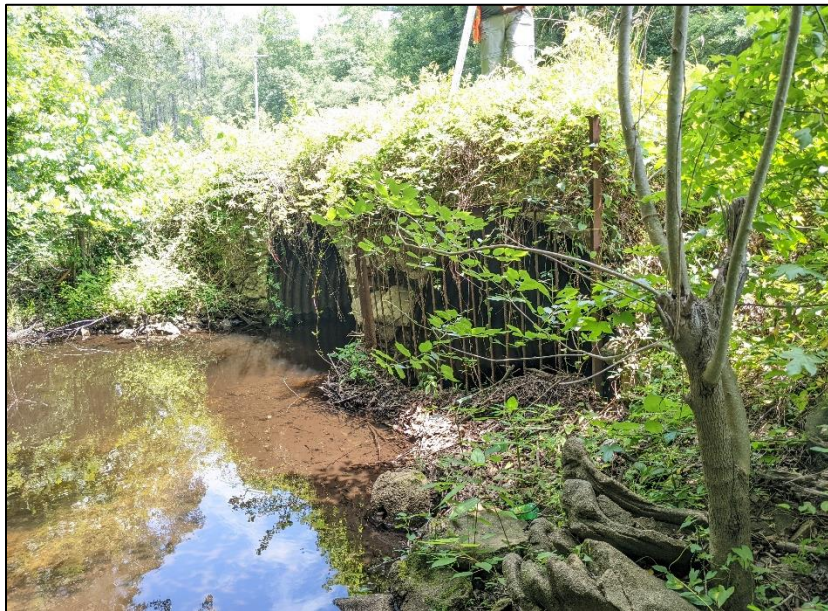
CPF350

This crossing is two CMP with a headwall made of concrete bags. A metal grate is present in front of one culvert barrel on the downstream side. The purpose of this grate is unclear, but potential beaver activity has formed a debris blockage on the downstream side of the grate. Fish passage appeared unimpeded in

the open culvert. To improve passage in the grated culvert barrel, debris should be removed regularly. The stability of the headwall should also be assessed, as several of the concrete bags were separated and falling from the wall on the downstream side.

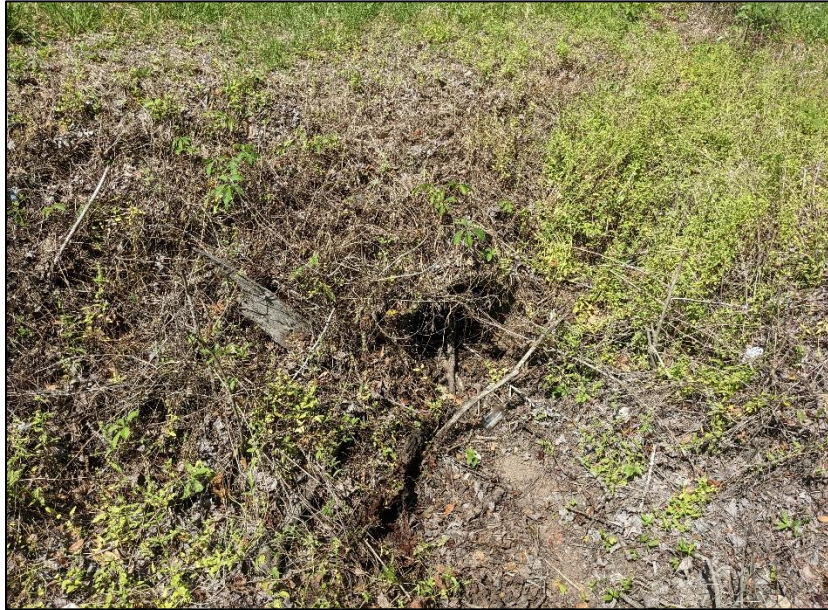
CPF354 is a small CMP in what appeared to be an ephemeral stream channel. The upstream side of the culvert was close to being covered by weedy vegetation. This area could be cleared regularly and monitored during and after storms to ensure that flow is not obstructed.

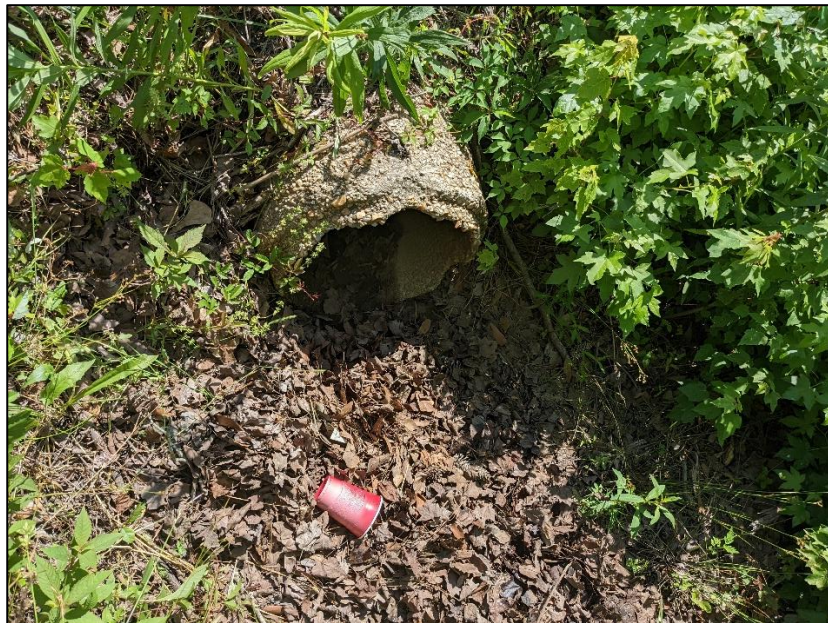
CPF356

This culvert is also a small CMP in an ephemeral channel. It is the most upstream of a cluster of culverts, with CPF133 and CPF354, that only occasionally receive flow. This area could be monitored following storms to ensure that debris build-up does not obstruct flow.

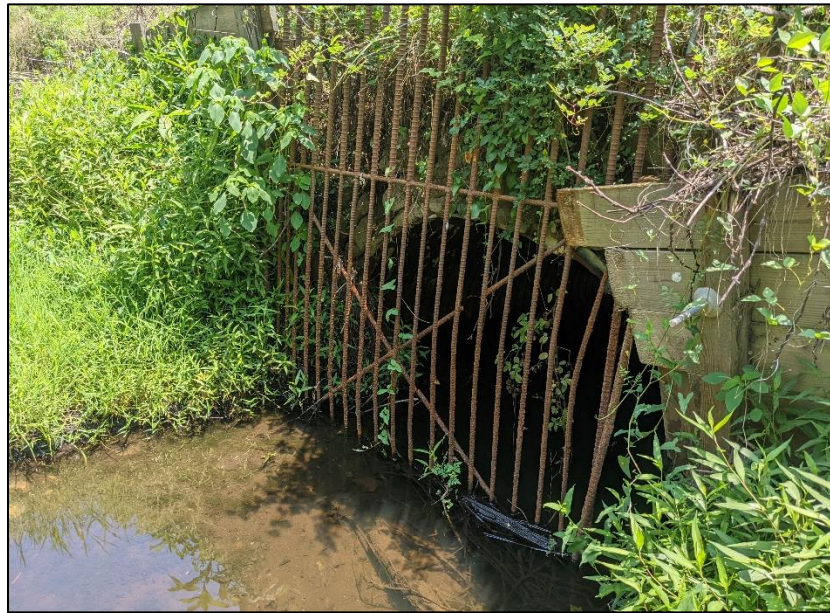
CPF358 is a single CMP with a metal grate on the outlet. The headwall is made of concrete bags and is visibly leaning on the downstream side. A small wooden structure was present on the downstream side, possibly to reinforce the wall. The spacing on the outlet grate may impede passage of some larger fish as well as attract debris. The stability of the headwall should be assessed at this crossing. The metal grate on the downstream side could be removed or debris cleared regularly to improve fish passage.

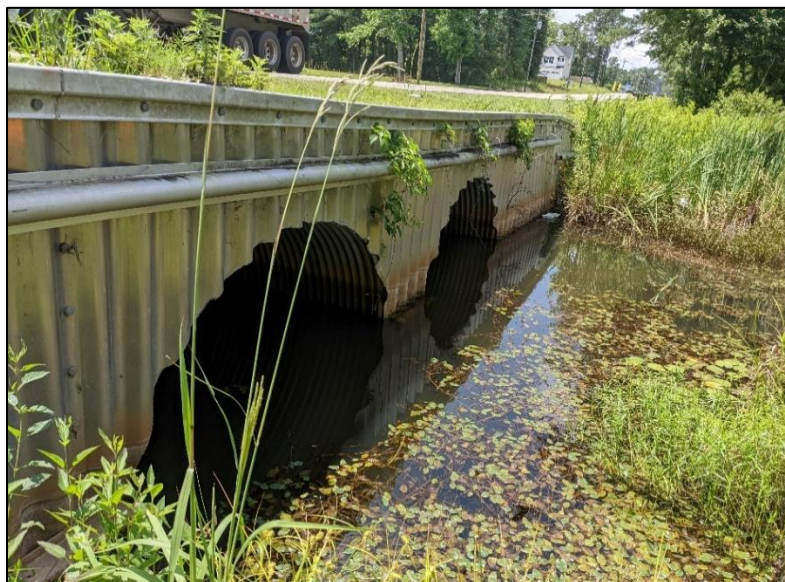
CPF360

This crossing has two culvert barrels in an aluminum headwall. The culvert and surrounding stream are located under a power corridor. The area appeared stable with no signs of erosion or functional issues, and major debris build-up was not observed. A large log had fallen near the inlet of one of the culvert barrels and could be removed to prevent future debris accumulation in that area. Fish passage did not appear to be restricted by this culvert in most flow conditions.

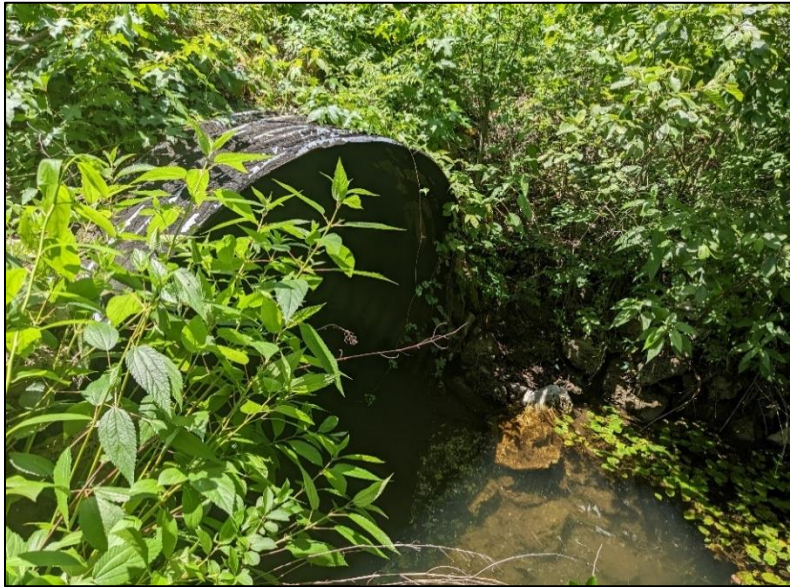
CPF362 is a single CMP barrel with a headwall. The culvert appeared to be in fine shape and no major erosion or functional issues were observed. There was no debris build-up surrounding the culvert, and fish passage did not appear to be restricted during normal flow conditions.

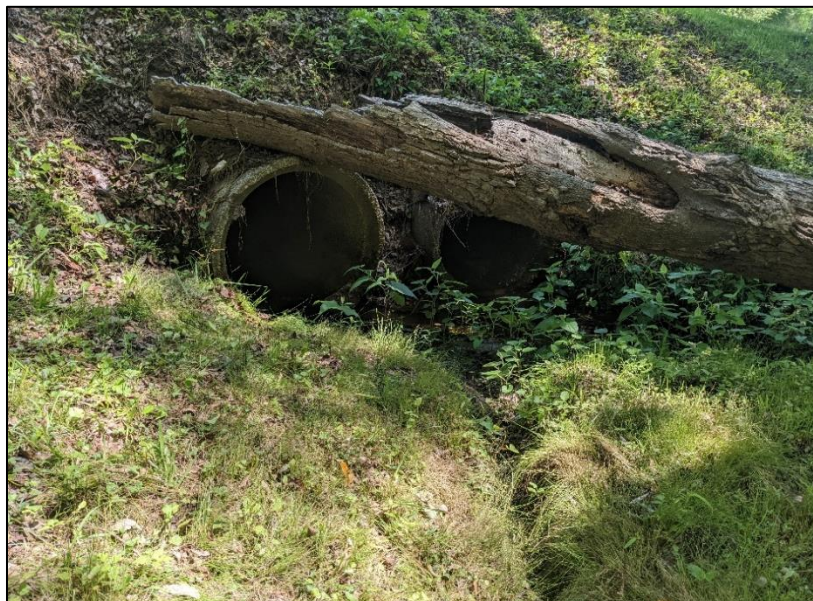
CPF366

This crossing is two RCP with a small braided channel upstream. A fallen tree trunk blocks most of the upstream channel and potentially impedes fish passage. Other than the tree, no debris or other obstructions were observed. This area could be monitored following storms to determine the extent of any upstream flooding.

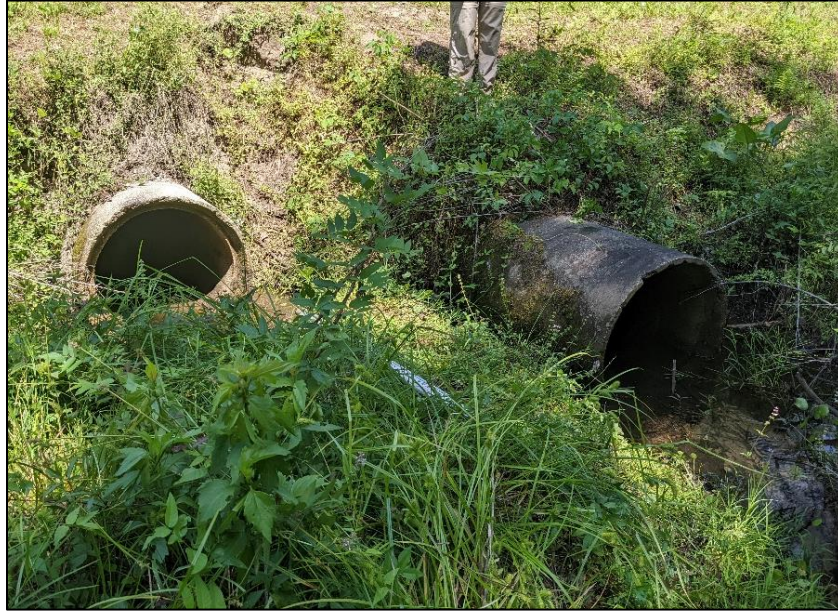
CPF368

This crossing is two RCP culverts located approximately 1,000 ft downstream of CPF366. Significant erosion was observed on the upstream side of the crossing. A neighbor informed us that during previous hurricanes, water had ponded upstream of the culverts up to the house and shed on their property. This area could be monitored during and following storms to determine the extent of upstream ponding, and to assess the need for larger culverts.

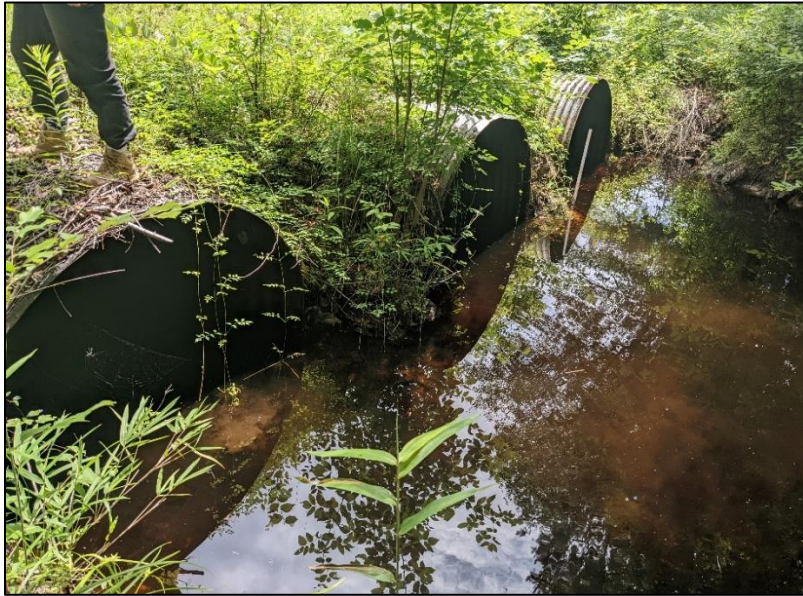
Unnumbered Crossing 1

This crossing is three CMP in failing condition. Woody debris accumulation was observed on top of the culvert outlet pipes, suggesting that flow may overtop the pipes on occasion. Significant erosion was also observed above the culverts. A layer of matting was present above the inlet side, but it appeared that some of the soil under the matting had washed away leaving an empty space behind the inlet headwall. This area should be further assessed for stability and repaired as necessary.

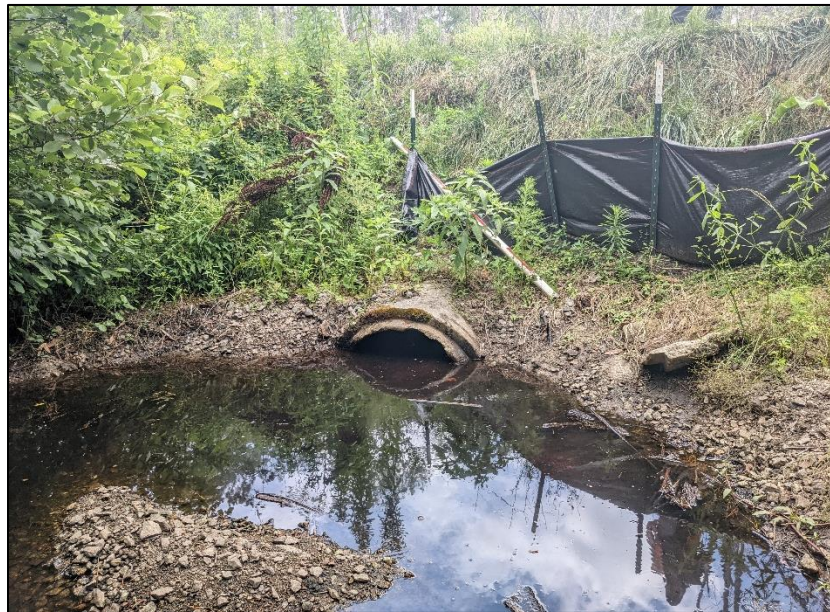
Unnumbered Crossing 2

This crossing is a single small RCP that has a recent repair of the slope and road above the pipe. Both sides of the pipe appeared to be sloped upward, so it is possible that the pipe is separated somewhere

under the road. A gravel dam was present downstream of the crossing, possibly left over from the road repair. This gravel is obstructing flow and could be removed.

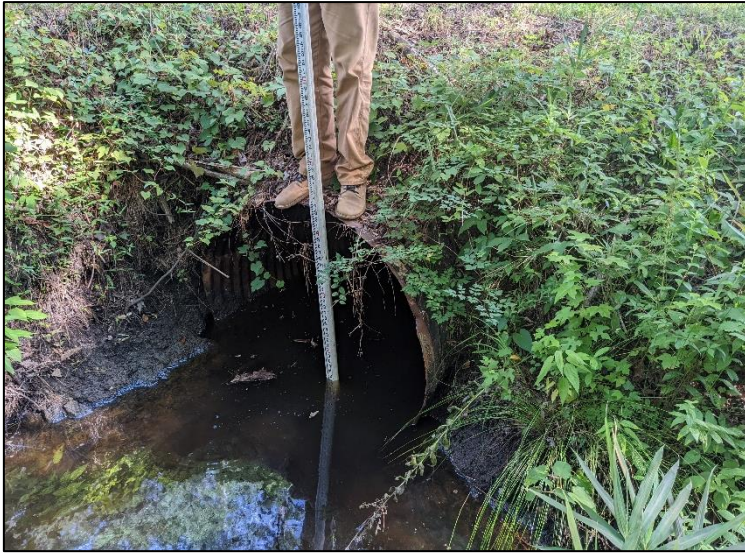
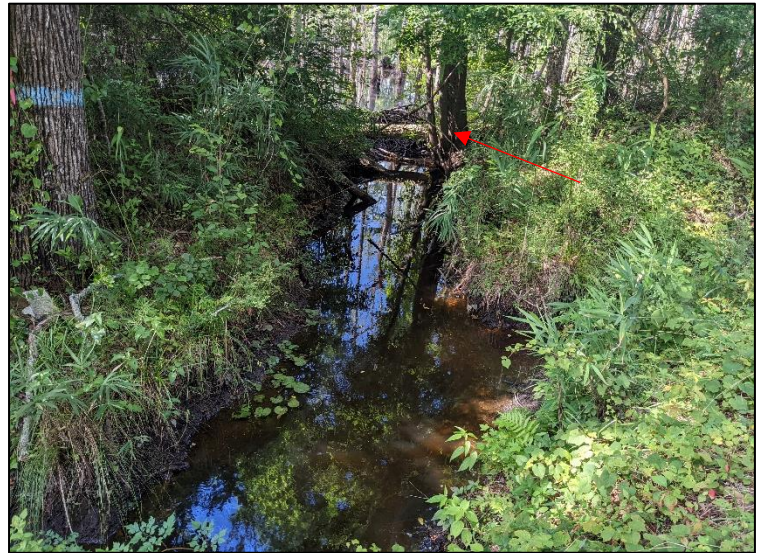
Unnumbered Crossing 3

The CMP at this crossing is in passable condition, however there is a beaver dam located roughly 100 ft upstream of the pipe. The dam was holding water several feet above the stream bed in July 2022 and preventing fish passage. This dam could be removed and area monitored for further beaver activity to improve fish passage.

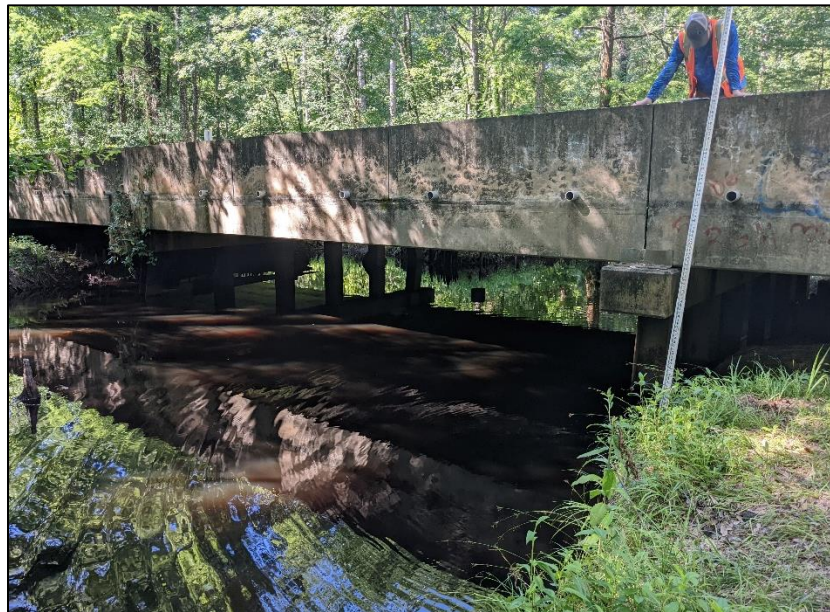
Unnumbered Crossing 4

Fish passage and flow capacity did not appear to be a problem at this bridge.

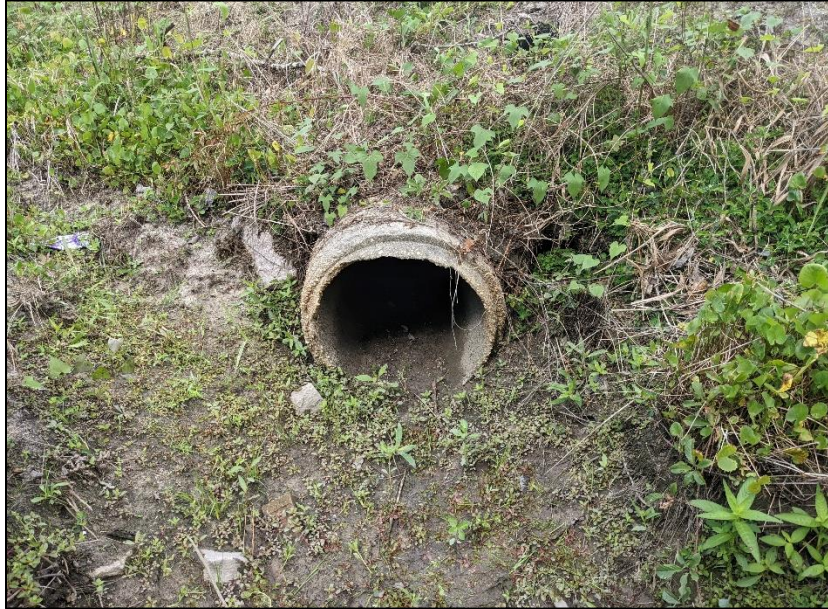
Unnumbered Crossing 5

This small RCP appears to be in an ephemeral channel. No flow was observed in early July 2022 when the crossing was assessed. However, a sediment and debris blockage upstream likely obstructs storm drainage during rainfall. This area could be kept clear of obstructions to improve the flow capacity of the culvert.

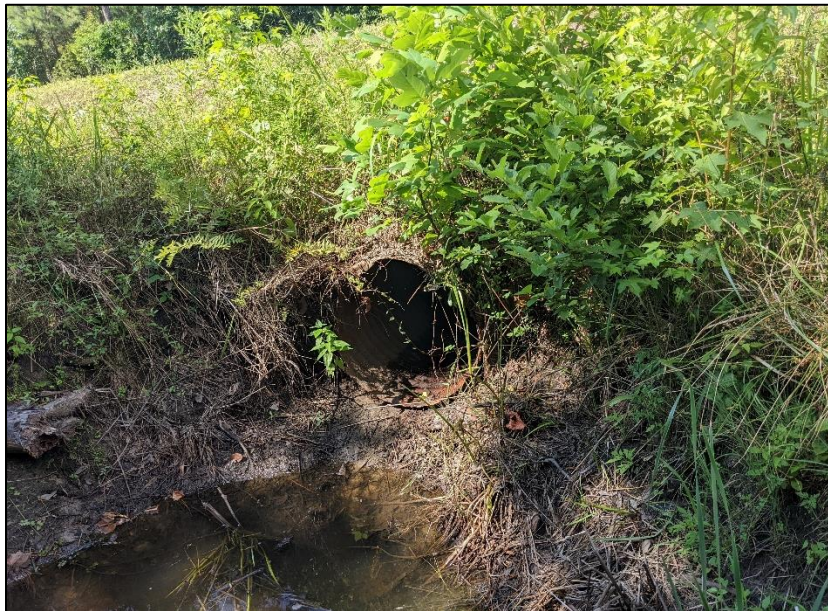
Unnumbered Crossing 6

This CMP is perched nearly a foot from the water surface and is in poor condition. Though the channel upstream is relatively small, erosion around the outlet pipe suggests that this area occasionally receives

high flow. This area could be regraded to remove the outlet perch or the pipe, which is old and rusting, could be replaced and set lower in the channel to improve passage.

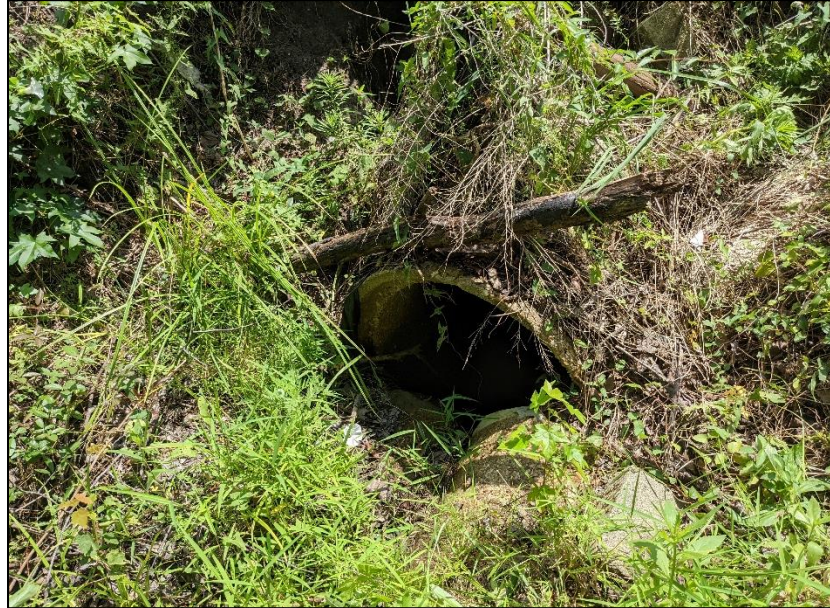
Unnumbered Crossing 7

The single RCP at this crossing is in failing condition, and more than one of the pipe joints have separated and fallen into the channel. There is also significant erosion above the pipe on the inlet side. The channel appeared ephemeral, but the outlet pool was still holding water when observed in July 2022. This pipe could be replaced and side slopes regraded before erosion in this area begins to threaten the road.

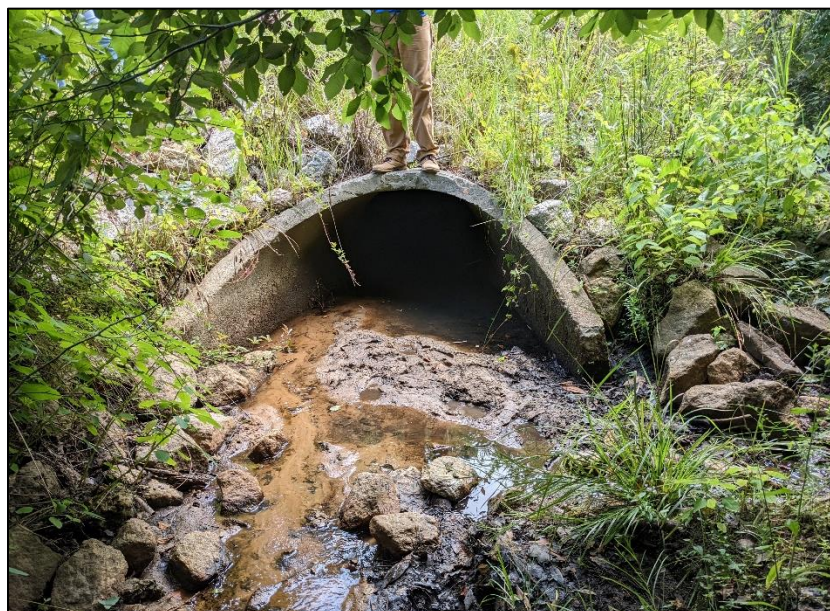
Unnumbered Crossing 8

This crossing is an RCP with attached flared end sections in a residential area. Badly eroding banks appear to be contributing to the heavy sediment load entering the inlet (pictured above). Rip-rap armoring in the downstream channel also appears to restrict fish passage. This rock could be rearranged or removed to enhance fish passage. Upstream channel banks could also be stabilized to reduce the incoming sediment and prevent build-up in the structure.

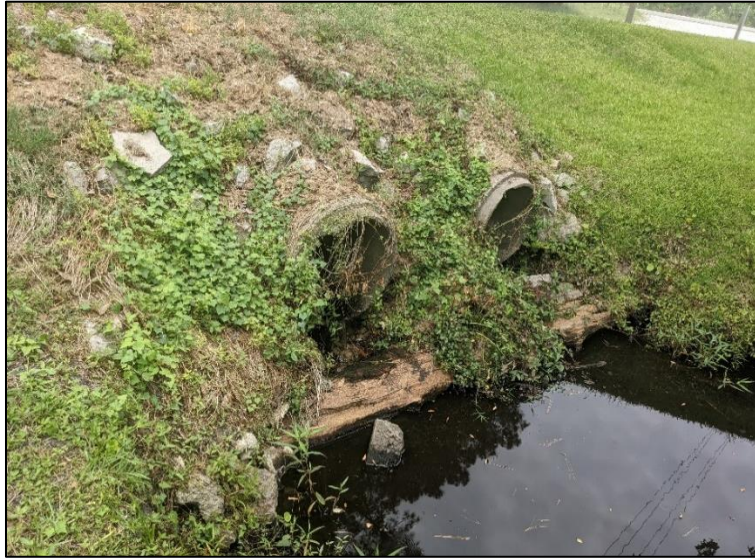
CPF86

This crossing is two RCP under an unpaved road adjacent to a gated horse pasture. The two culverts are perched roughly a foot above the water, preventing upstream passage except for during storms. An unpaved road makes culvert replacement less difficult than if pavement had to be disturbed.

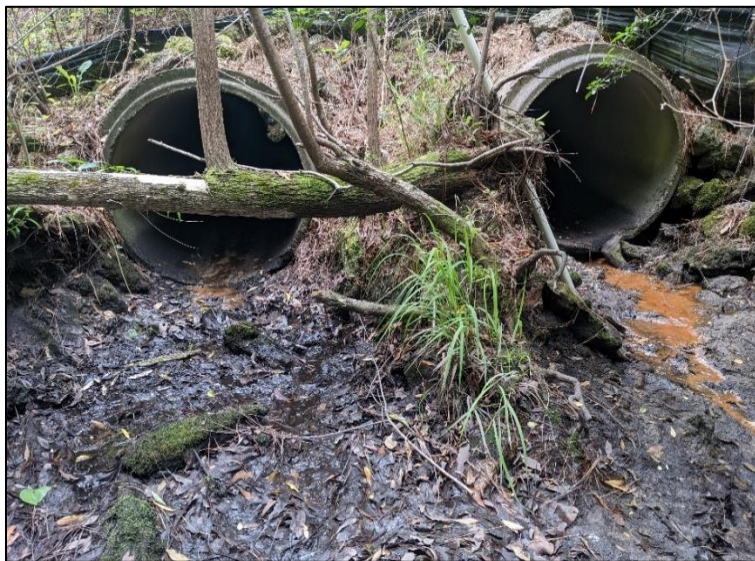
CPF88

This crossing is two RCP, both slightly perched on the outlet side. These culverts appear to be located on an old/abandoned subdivision plot where paved roads have been constructed but no houses were ever built. The crossing may be easier to improve than other culverts because there is no traffic over the site.
