Erosion of Aquatic Habitat in the Cape Fear Estuary: What's Known, What's New and What's Next?

James McDaid Kapetsky, Ph.D.
Associate Member, Eagles Island Coalition

Cape Fear River Partnership
1st Quarter Meeting
Fayetteville, NC
February 24, 2020

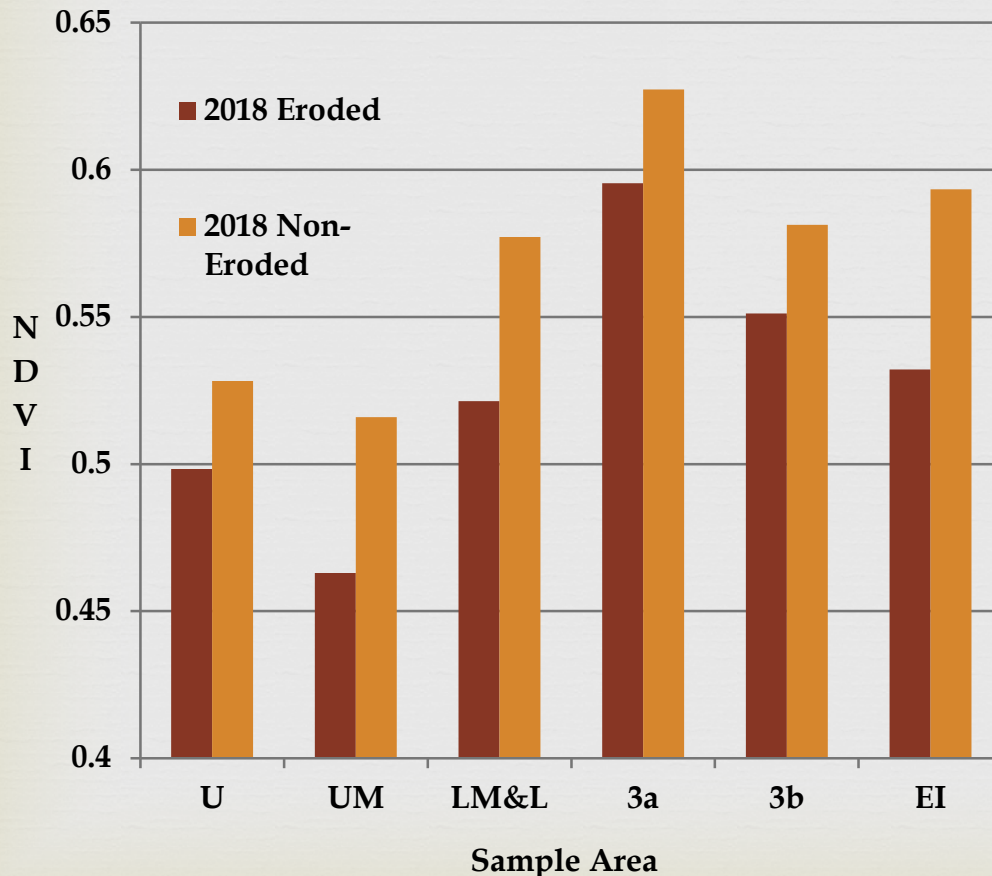
Mean NDVI in Eroded and Non-Eroded Marsh Areas at Six Locations on 8/24/2018

- NDVI indicative of marsh vegetation health
- Based on Planetscope multiband 3 m and NAIP 1 m multi-band imagery
- Comparisons of vegetation health in eroded and non-eroded marsh
- 6 locations (806 ha in total) x dates in 6 years = 36 comparisons in all

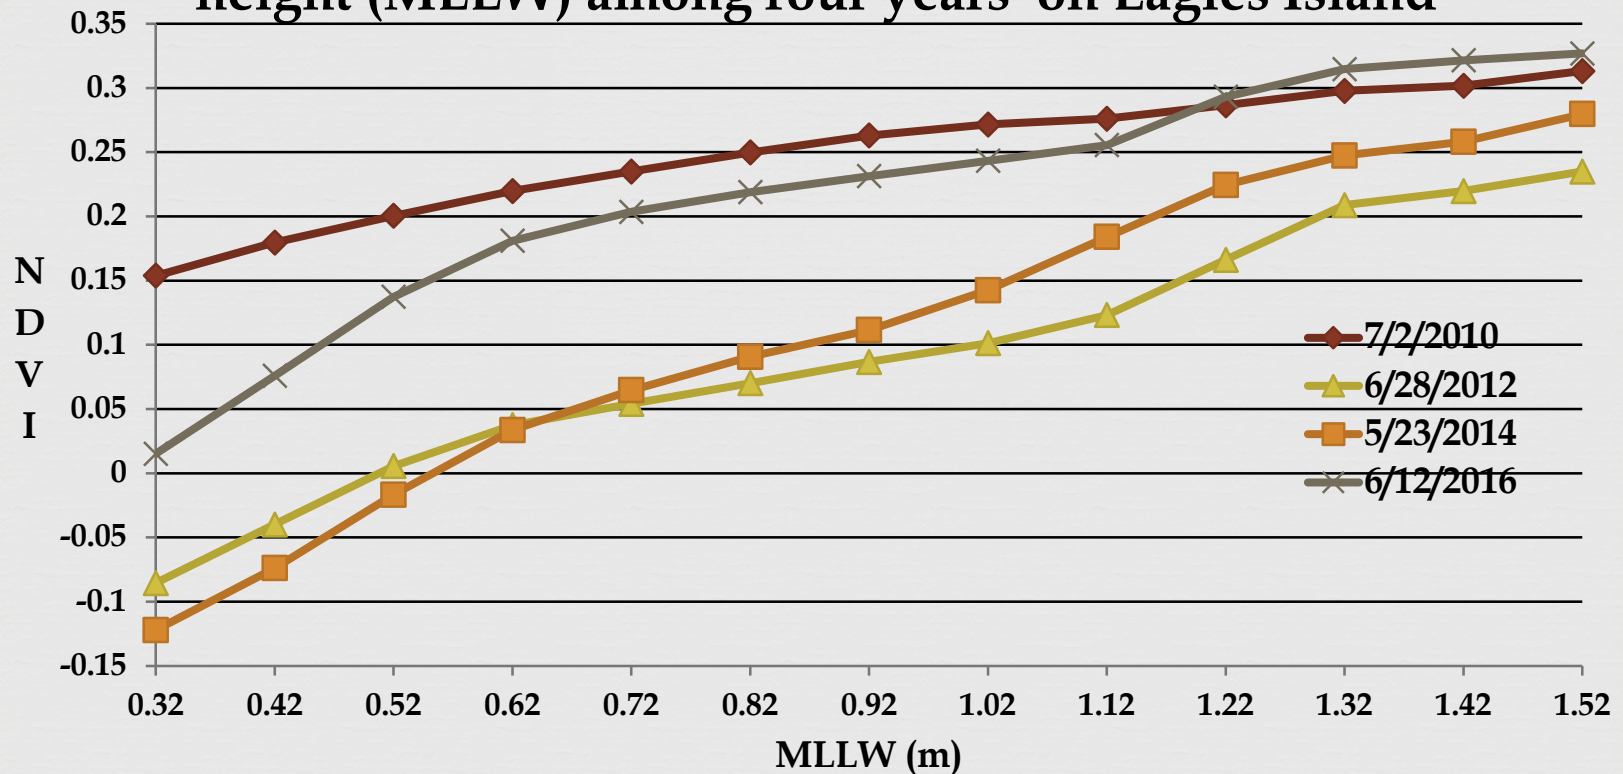
Marsh vegetation health (NDVI) by 10 cm contour height (MLLW) among four years on Eagles Island

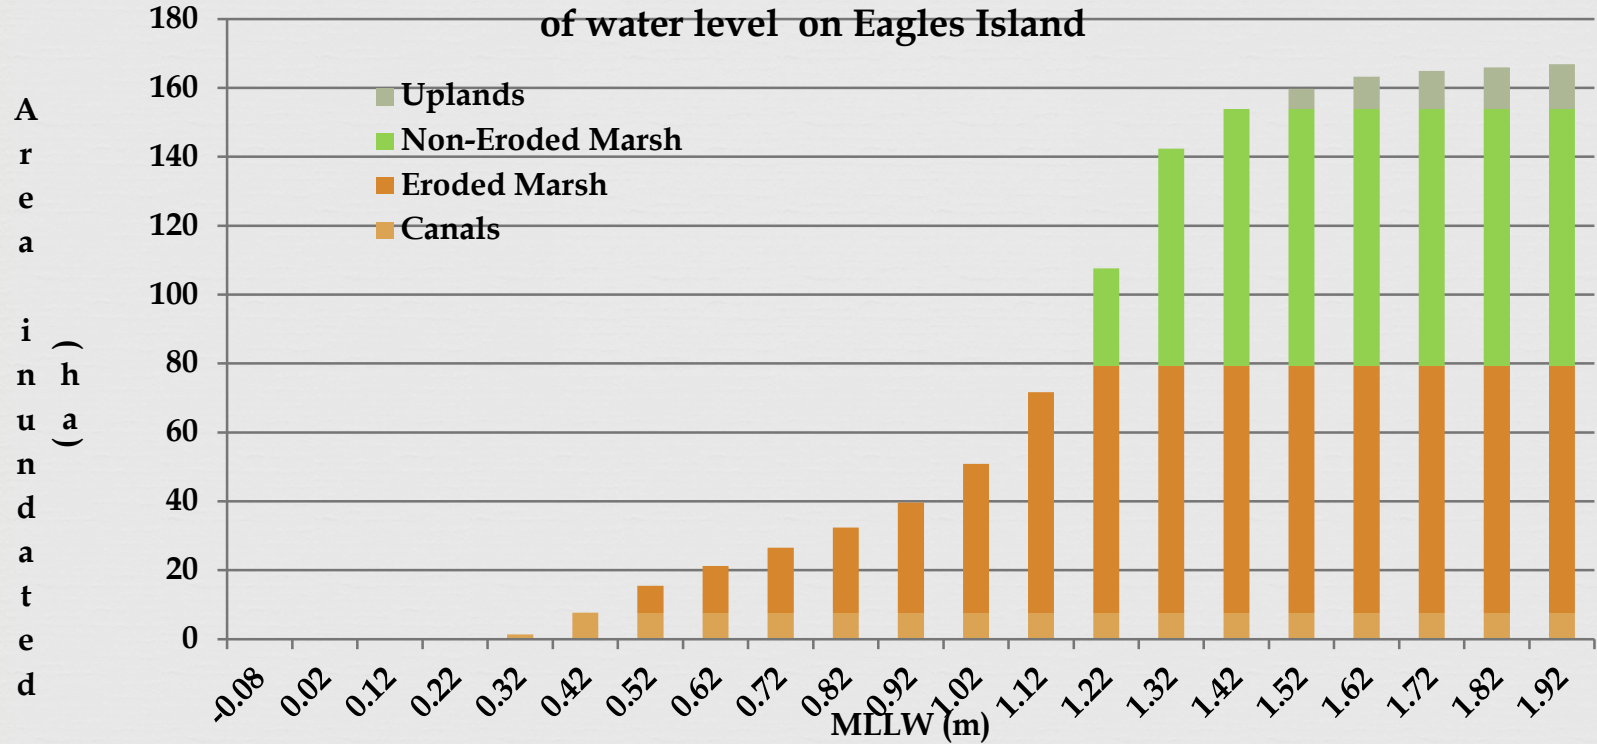
Cumulative area inundated in eroded areas by habitat type as a function of water level on Eagles Island

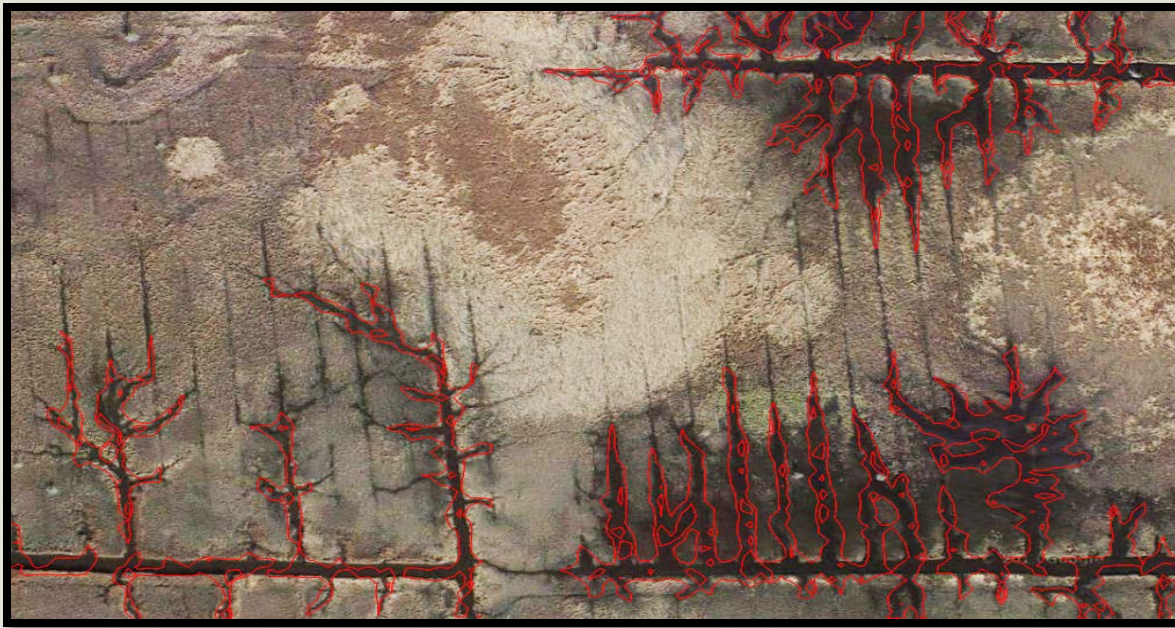
Ponding during cold season as a surrogate for LiDAR

20 cm 2014 LiDAR contour over Google Earth

Indicative Erosion Rates (ha/y)

Location	Historical 1949 to 2001 (Ponding)	Recent 2001 to 2014 (LiDAR)
EI	0.7	1.3
U	1.0	-0.8
UM	1.0	0.7
LM&L	1.2	0.3
CFR 3a	0.3	4.3
CFR 3b	0.7	0.6

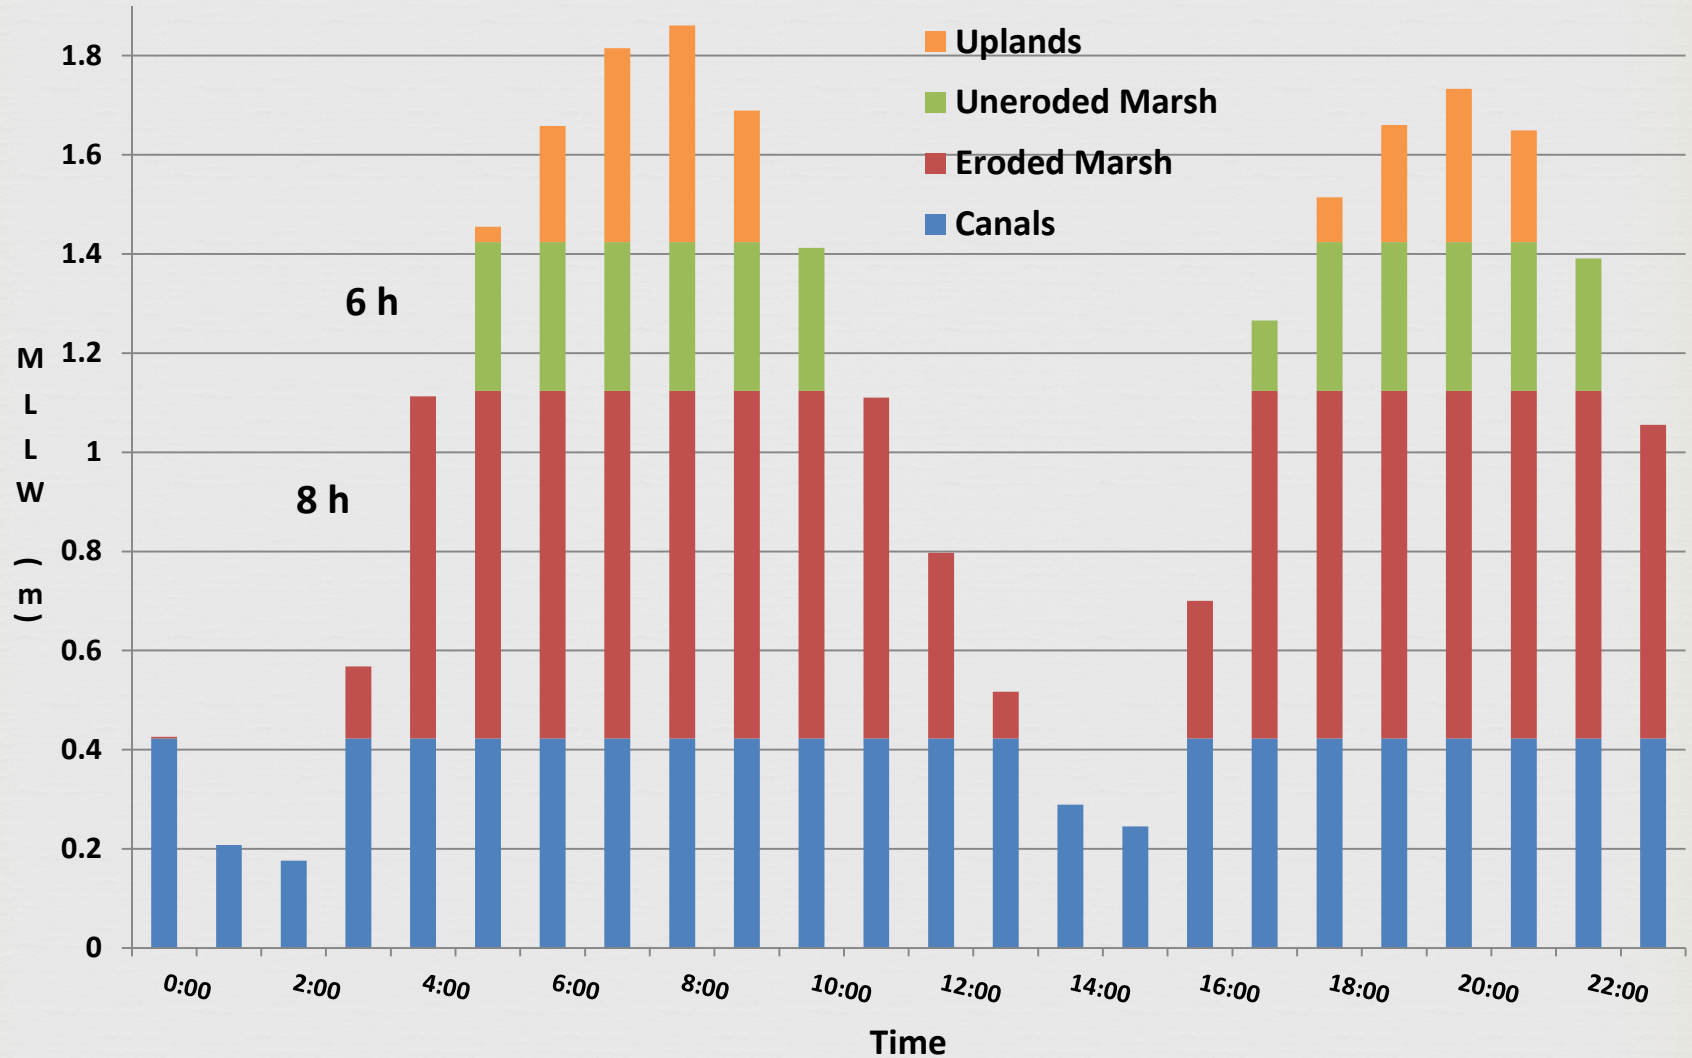
Height (m) and duration (h) of inundation based on hourly water levels in four habitat types on Eagles Island on February 27, 2014

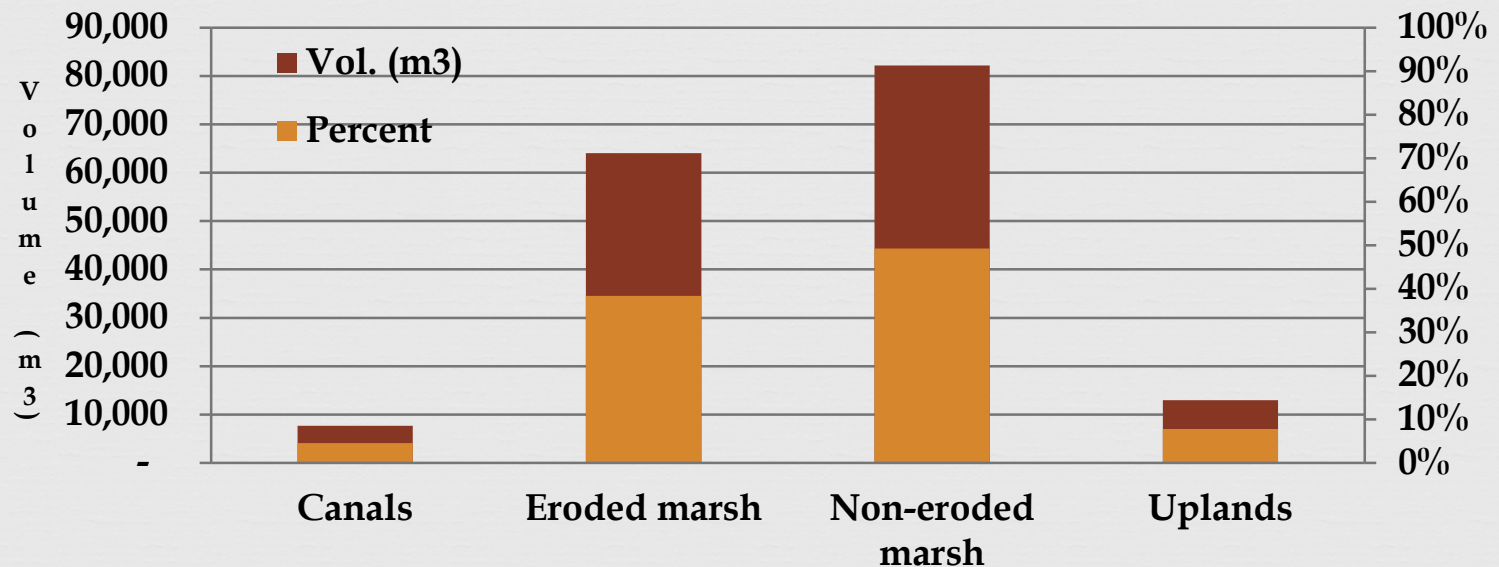
Volume by habitat when fully inundated in areas where erosion occurs on Eagles Island

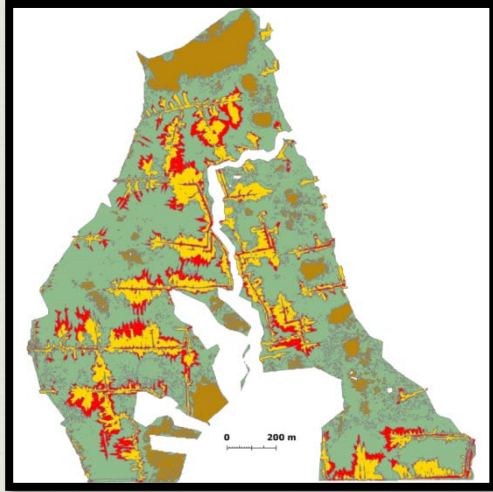
EI
172 ha **E 1.3** **A -0.1**

How do erosion & accretion rates compare 2001 to 2014 (ha/y)?

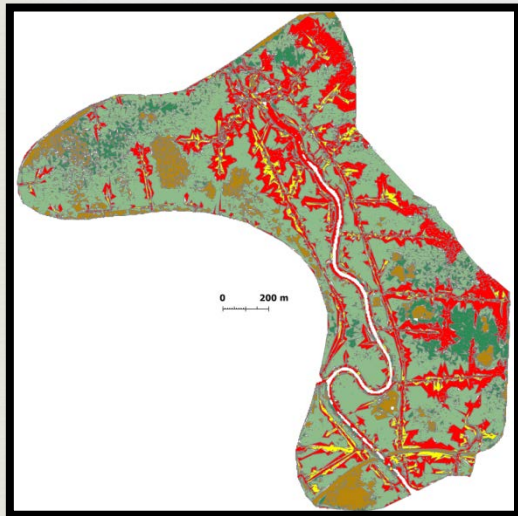
CFR 3a 197 ha **E 4.3** **A -2.3**

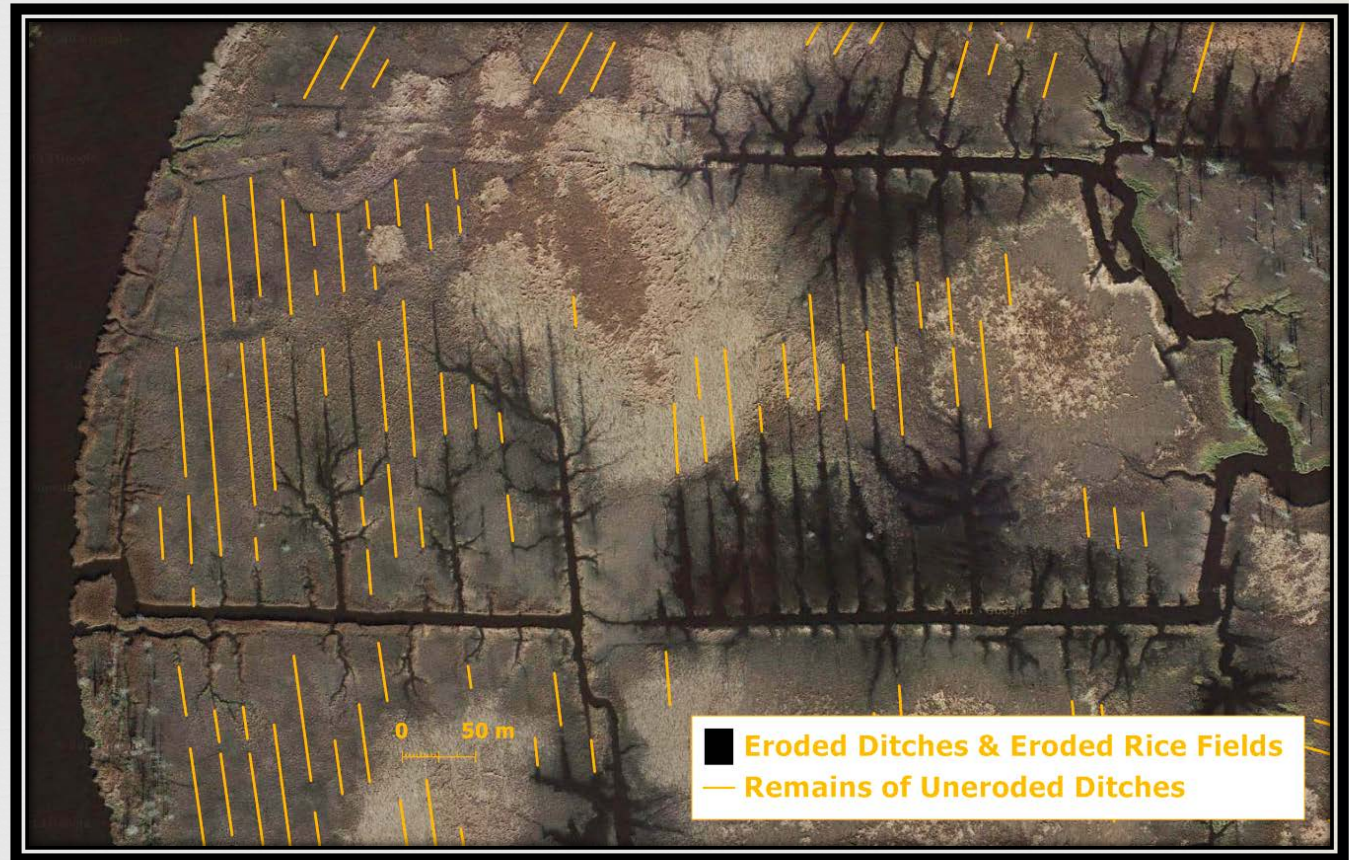
Digitized remains of rice field ditches over Google Maps Satellite image

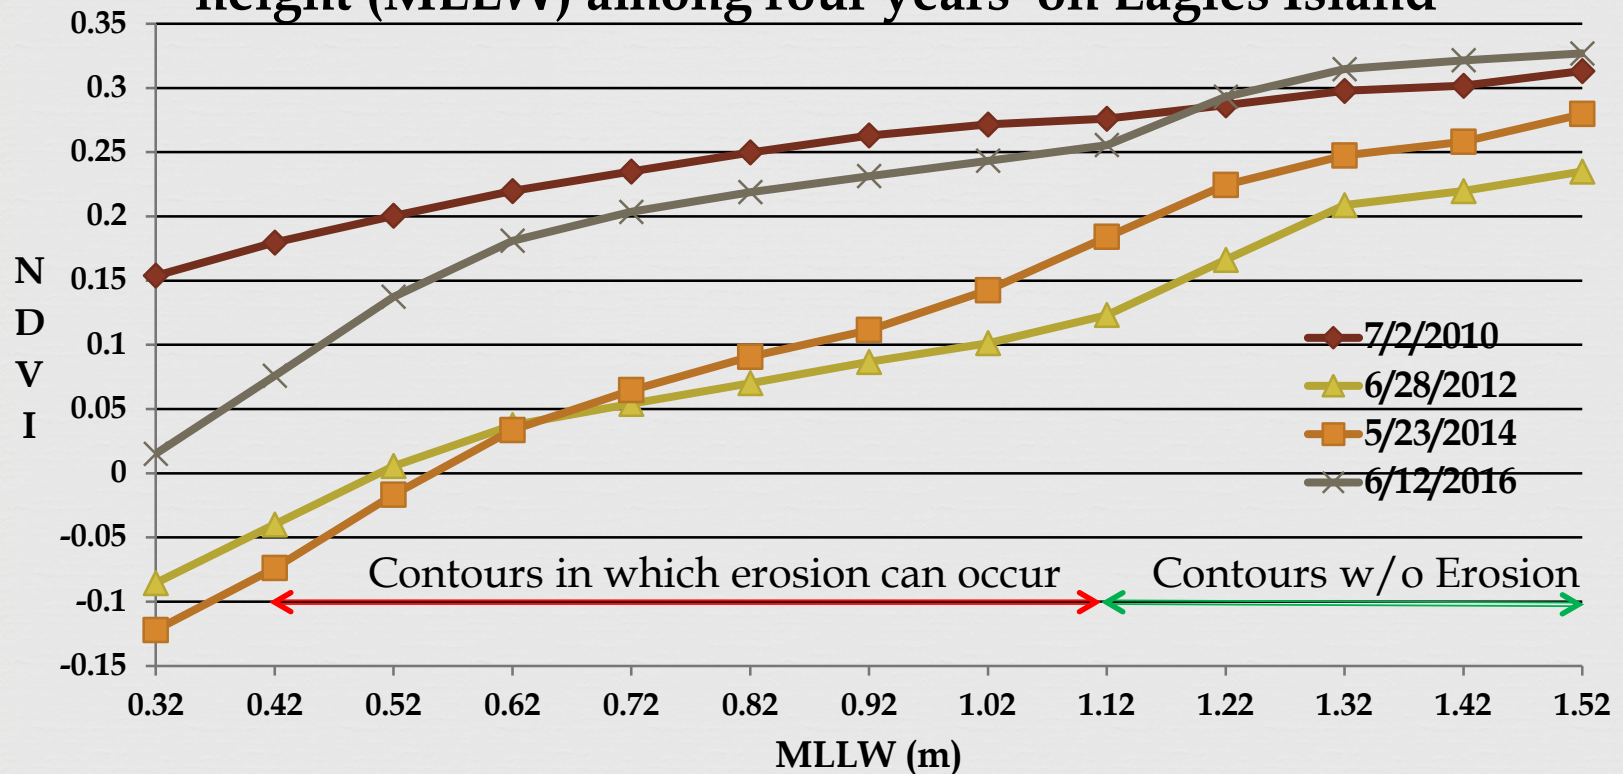
Marsh vegetation health (NDVI) by 10 cm contour height (MLLW) among four years on Eagles Island

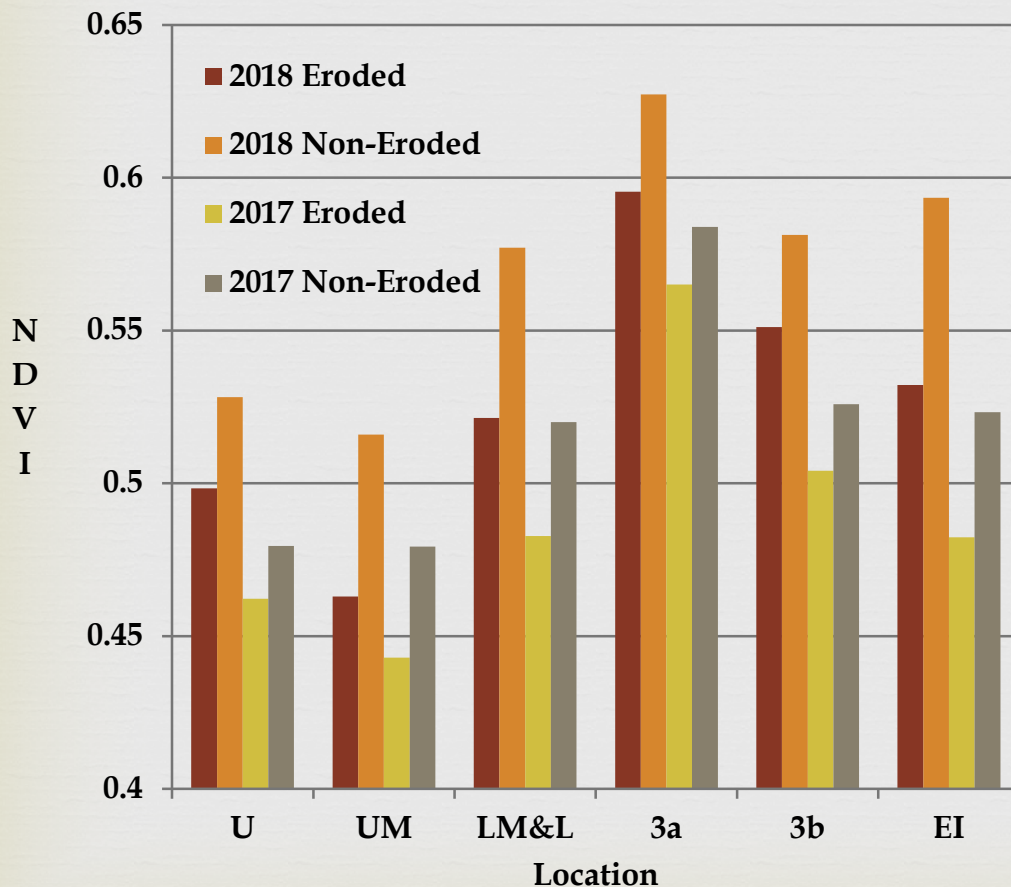
Mean NDVI in Eroded and Non-Eroded Marsh Areas at Six Locations on 8/24/2018 and 7/21/2017

- NDVI indicates marsh vegetation health
- Based on Planetscope multiband 3 m and NAIP 1 m imagery
- Comparisons of vegetation health in eroded and non-eroded marsh
- 6 locations (806 ha in total) x dates in 6 years = 36 comparisons in all
