Lock and Dam 1; Improving Fish Passage

Fish Passage Basis of Design

Fish Passage Modifications at Lock & Dam No. 1

Fish Passage Improvements

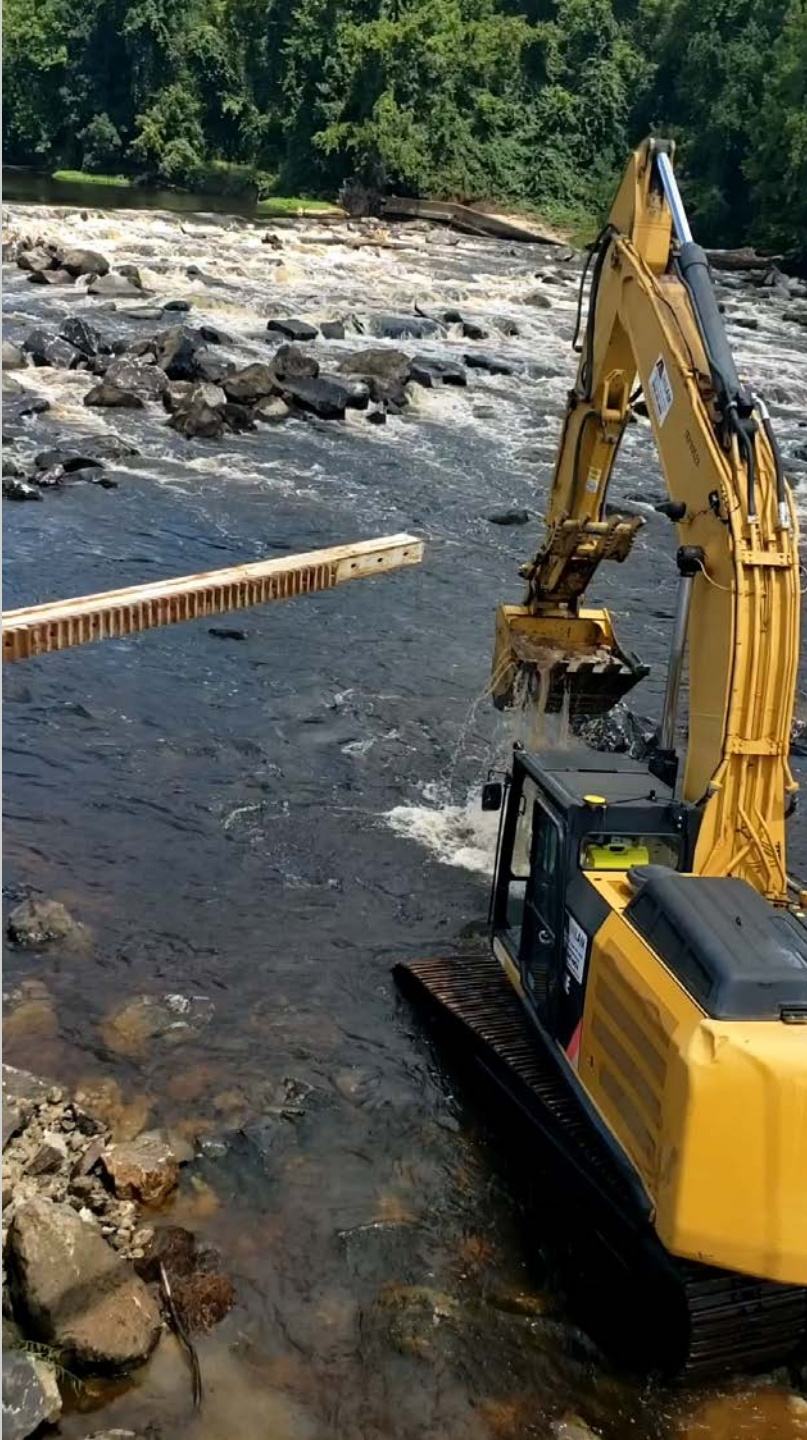
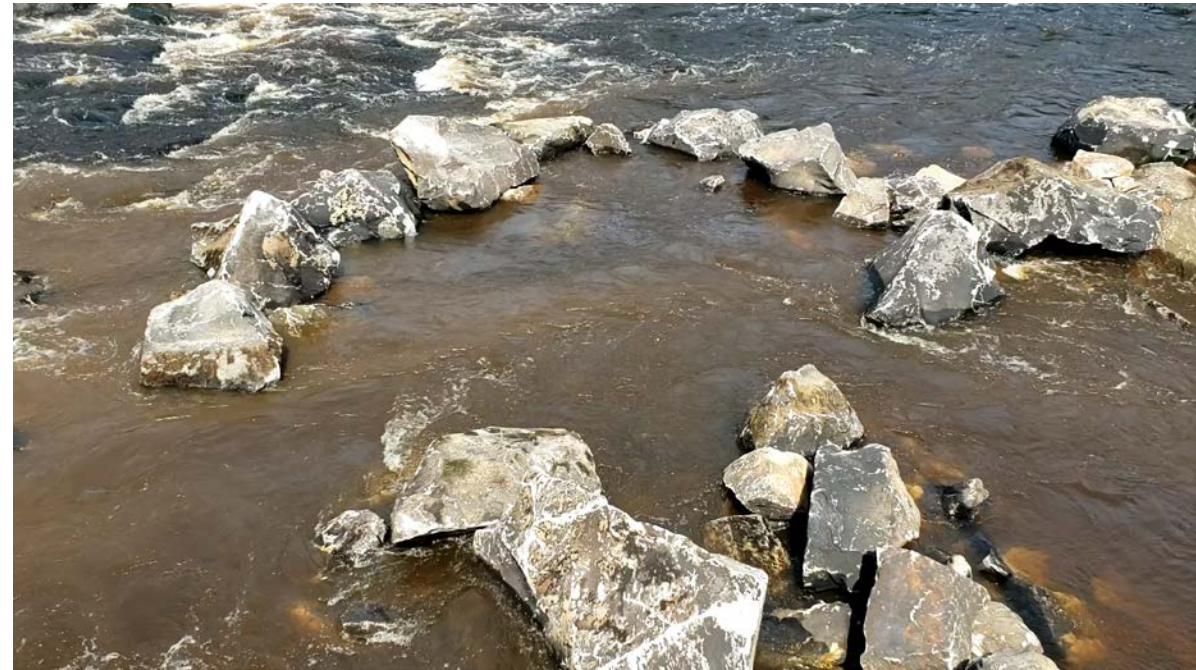
Creating Pools

- › Video 1: Creating a bed for the weir stones
- › Video 2: Flows within first pools (8/19/2021)

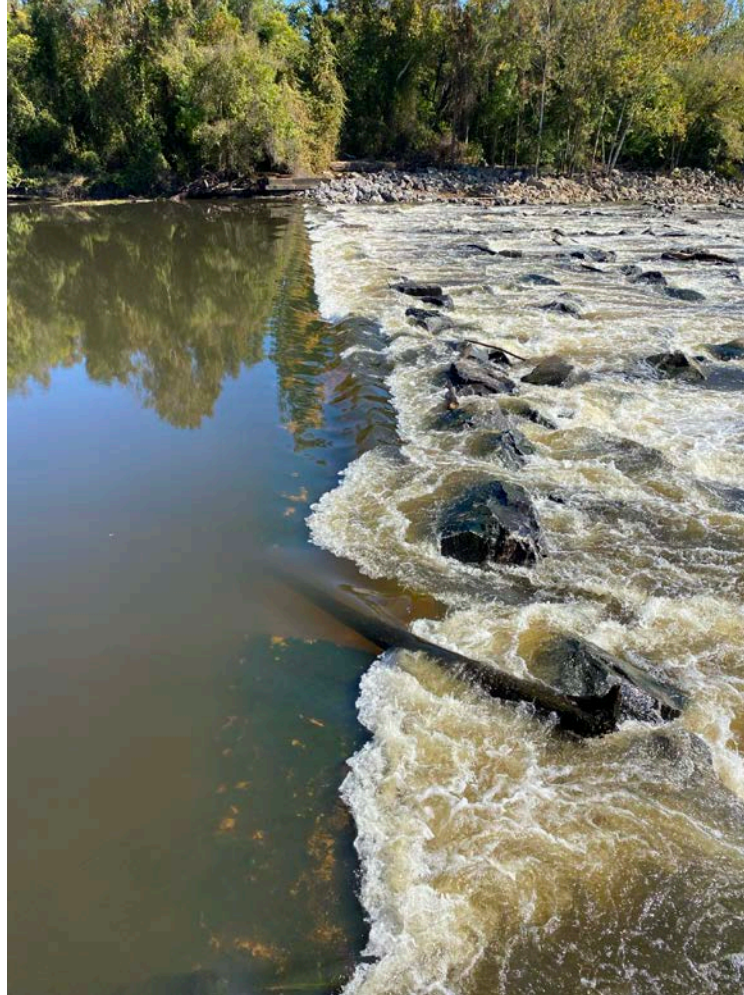
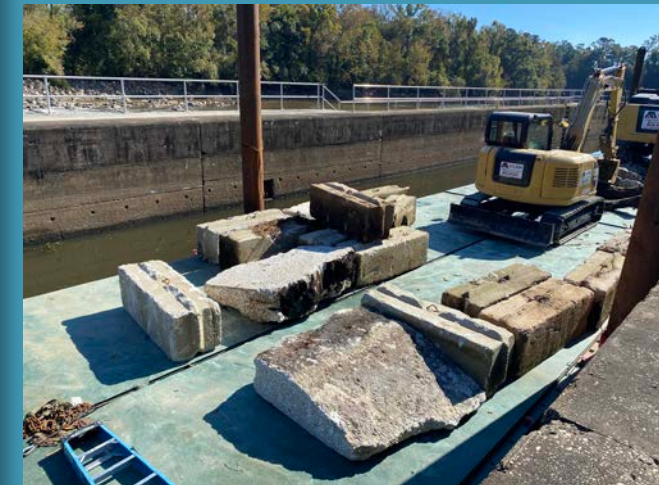
Notches

- › Three notches for each flow channel
- › Each notch is 2 ft high by 5.5 ft wide
- › Dam crest remnant to stay on-site for education

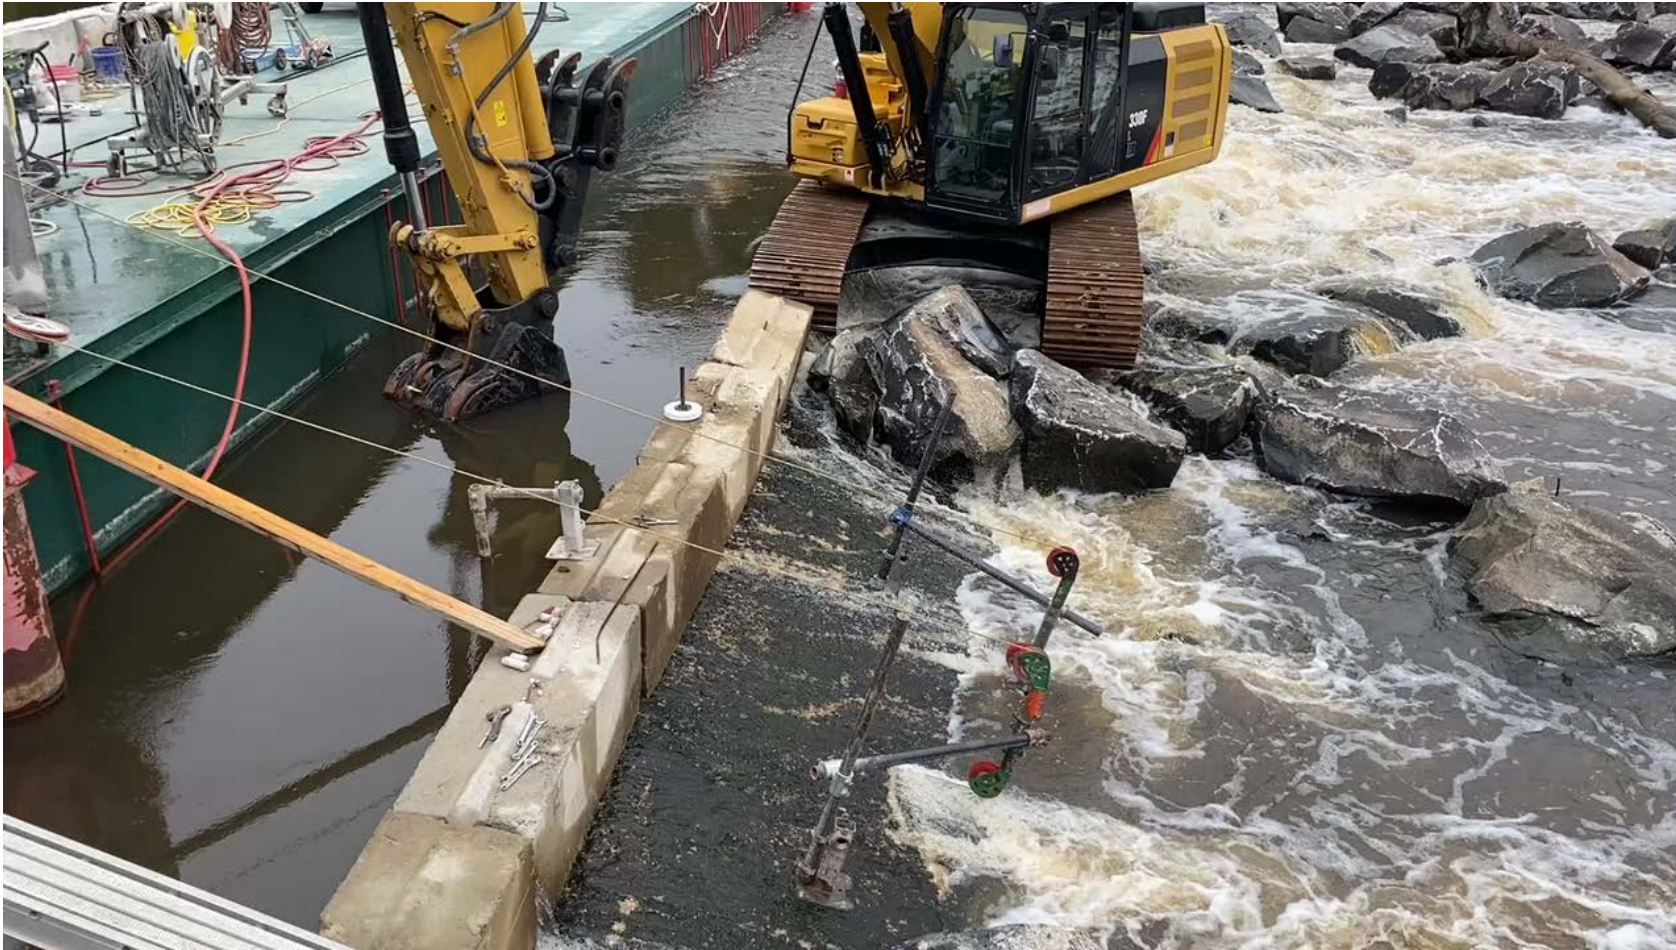
Notch Cutting

› Wire saw was used with metal wire coated in diamonds

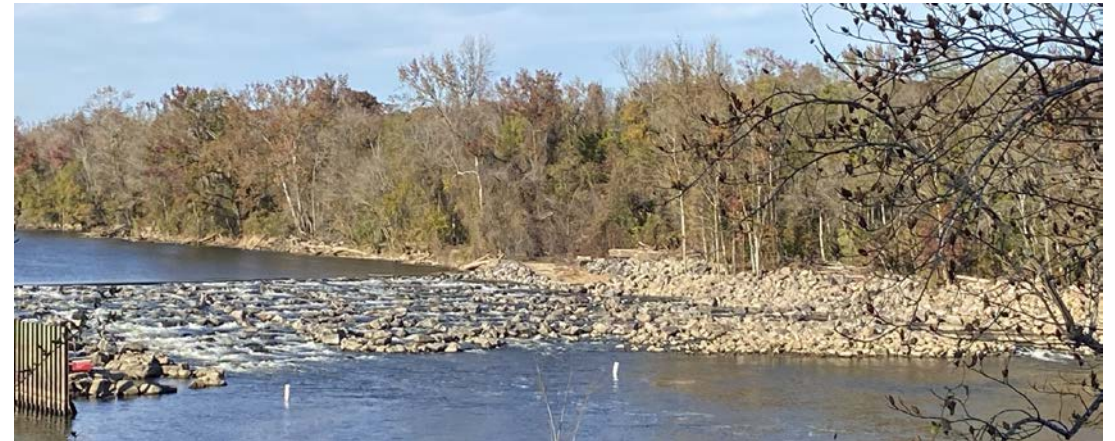
November 10, 2021

- › Project Completed
- › Note three notches
- › All equipment demobilized
